All models

Retighten bolts/self-locking nuts of exhaust flange connections. Torque to 20 Nm.

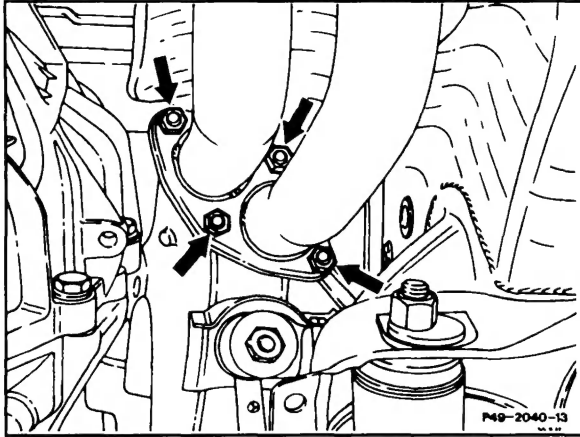
Model 201.02 up through 09.1984
(Non-catalyst model shown for location of bolts.)

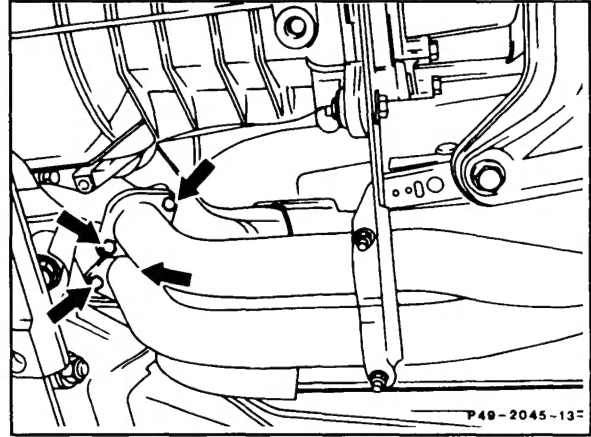
Model 201.02 as of 10.1984 and 201.03
(Non-catalyst model shown for location of bolts.)
